*King's Cross Fire in the
London Underground
November 18, 1987*

*A Report for
Dr A. Buchanan
Dept. of Civil Engineering
Canterbury University*

*by Deane McNulty
and
Philip Rielly
March 1992*

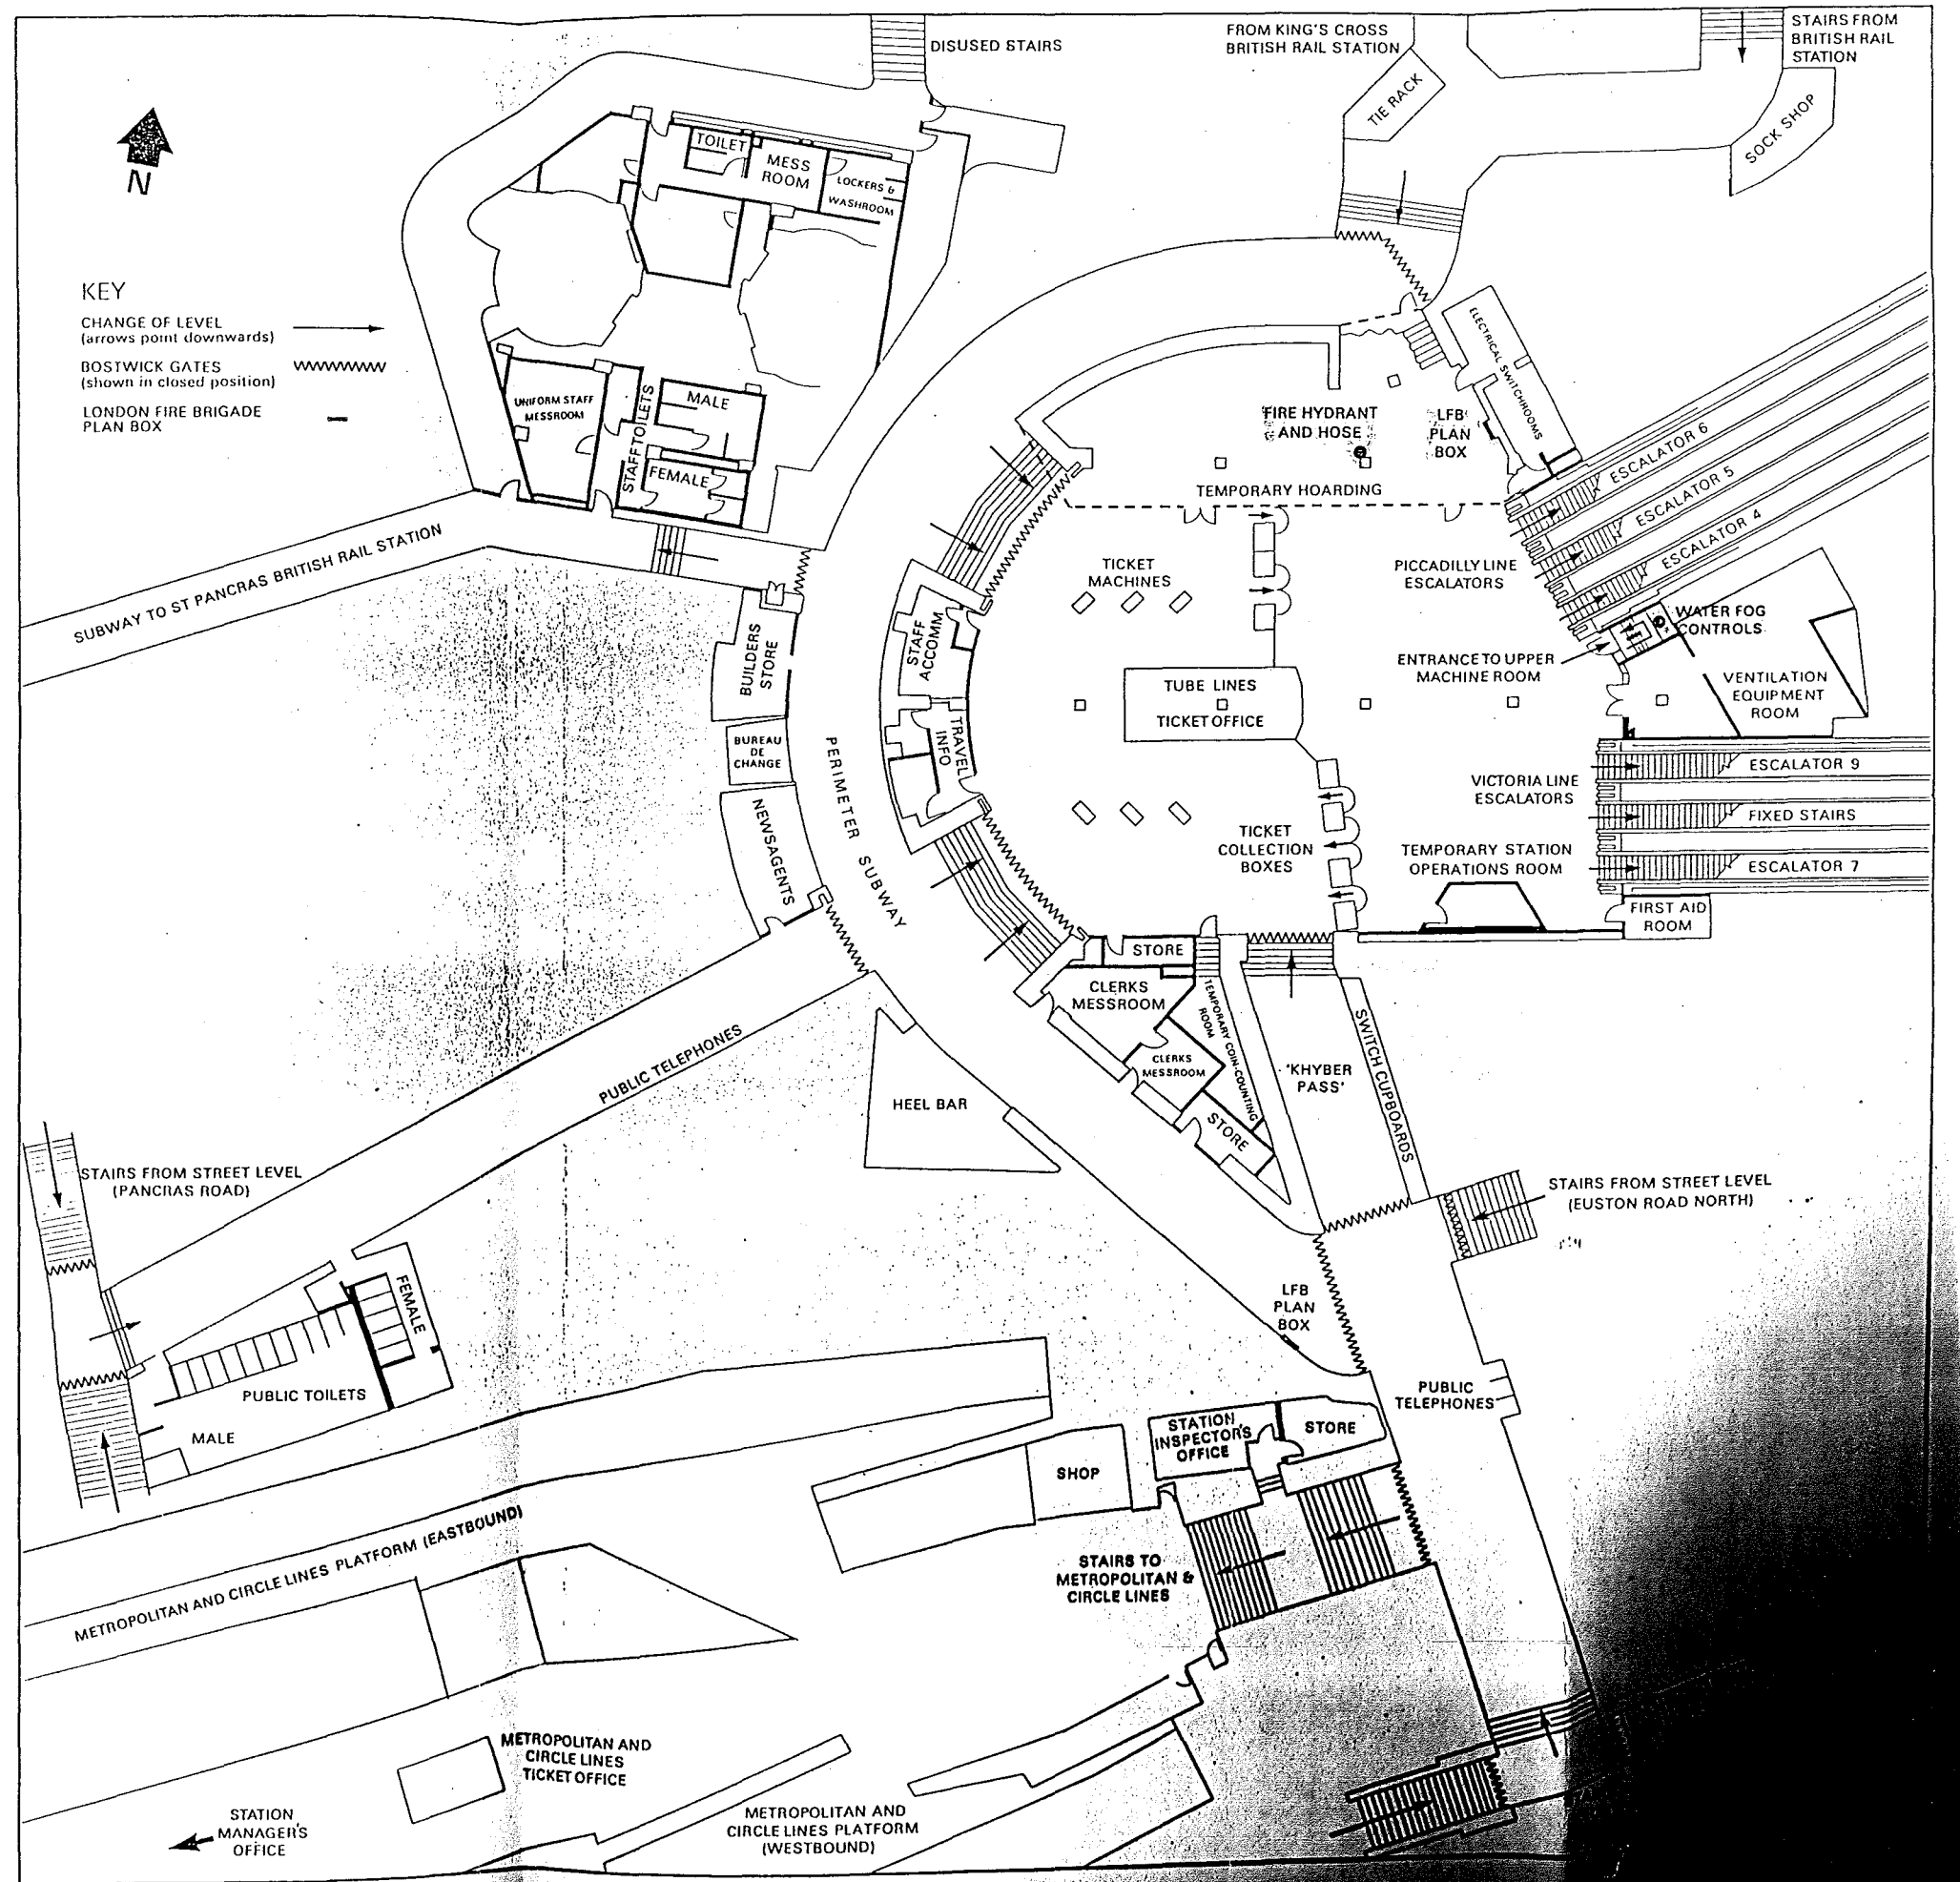
FIGURE 1

The area of importance on the night of the disaster was the Tube Lines Ticket Hall (figure 1). There are two sets of escalators from the tube lines ticket hall, one serving the Northern and Piccadilly lines (where the fire started), and the other the Victoria line. In the ticket hall itself, a temporary hoarding had been erected across the right hand side of the ticket hall looking to the street from the Piccadilly escalator. This was to conceal from the public view workmen who were constructing a new station operations room. The hoarding had been painted with approved paint, but it also covered from view and access by people in the ticket hall the only fire hydrant and hose in the ticket hall area.

19:42 - Station Inspector went to ticket hall via Khyber Pass (figure 1), opening security gates en route, and met Relief Station Inspector who had just come out of upper machine room.
